*DFI-Use of Structural Slurry Wall for Permanent Structures
August 10th, 2011(Toronto, Canada).*

**PERMANENT SLURRY WALLS USED IN
TORONTO'S DEEPEST SHAFT
TO FIX THE COXWELL EMERGENCY BYPASS**

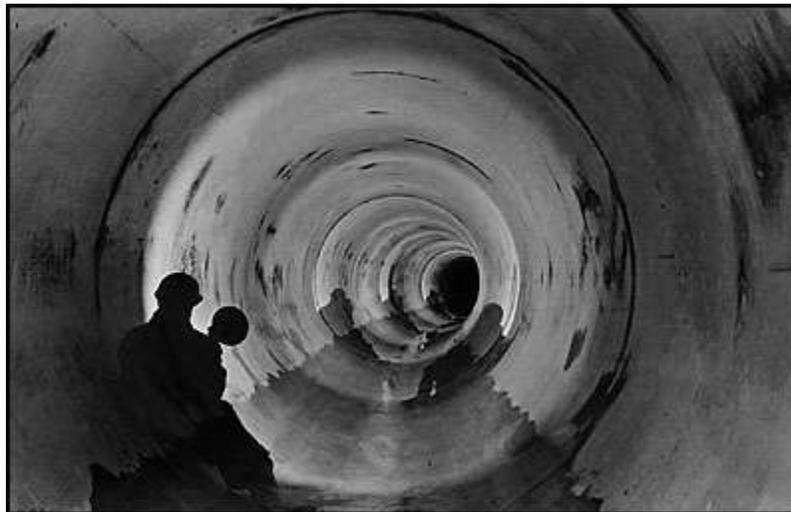
Existing Coxwell Trunk Sewer – Circa 1960 – Toronto Archives

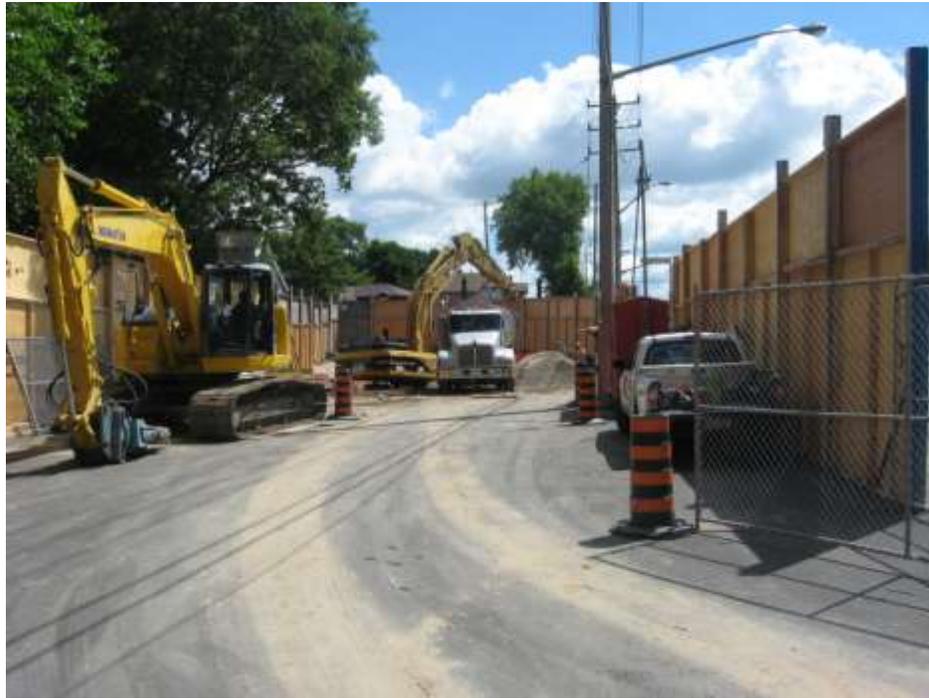
Figure 1. General site at the Exit Shaft location.

While the City acknowledges that construction always has an effect on a neighbourhood. The disruption to local residents is to be kept to an absolute minimum. To alleviate these issues regular information is issued keeping residents aware of construction progress. Figure 1 shows the general site compound and its limited area, making the work most challenging.

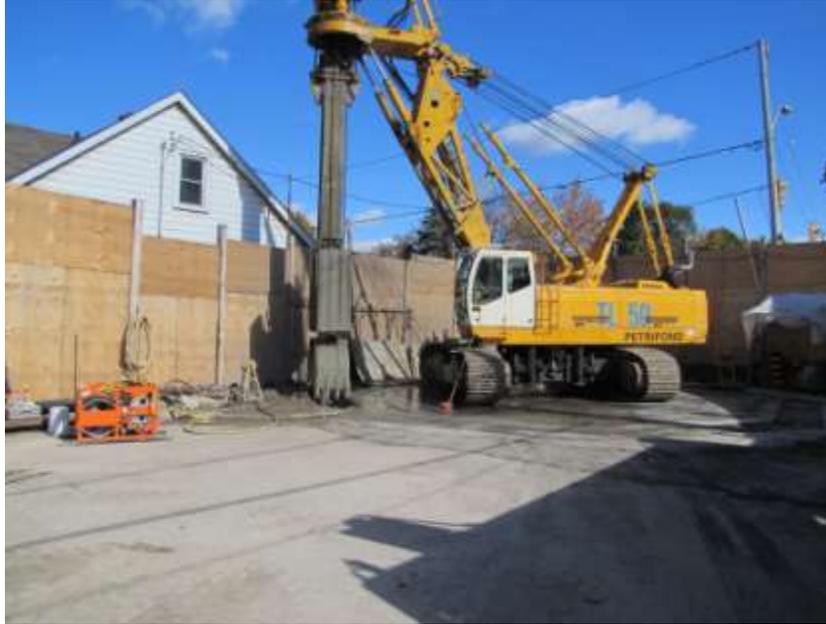
Figure 3. Slurry Wall rig used to excavate the panels.

The choice of equipment stemmed from the project challenges mentioned. In addition, panel alignment and verticality are the most essential elements for a successful result in a circular shaft. As such, to excavate panels to a depth of 47 M, Petrifond decided to utilize a hydraulic pile rig equipped with specialized hydraulic clamshell buckets. The KRC Casagrande hydraulic clamshell bucket is fixed to a rigid Kelly bar enhancing vertical excavation tolerance through the dense soils. In addition the clamshell piston offers a closing force of 200-Ton, which was required to overcome the very dense till matrix. Figure 3 shows excavation rig slurry wall equipment excavating at the Shaft.

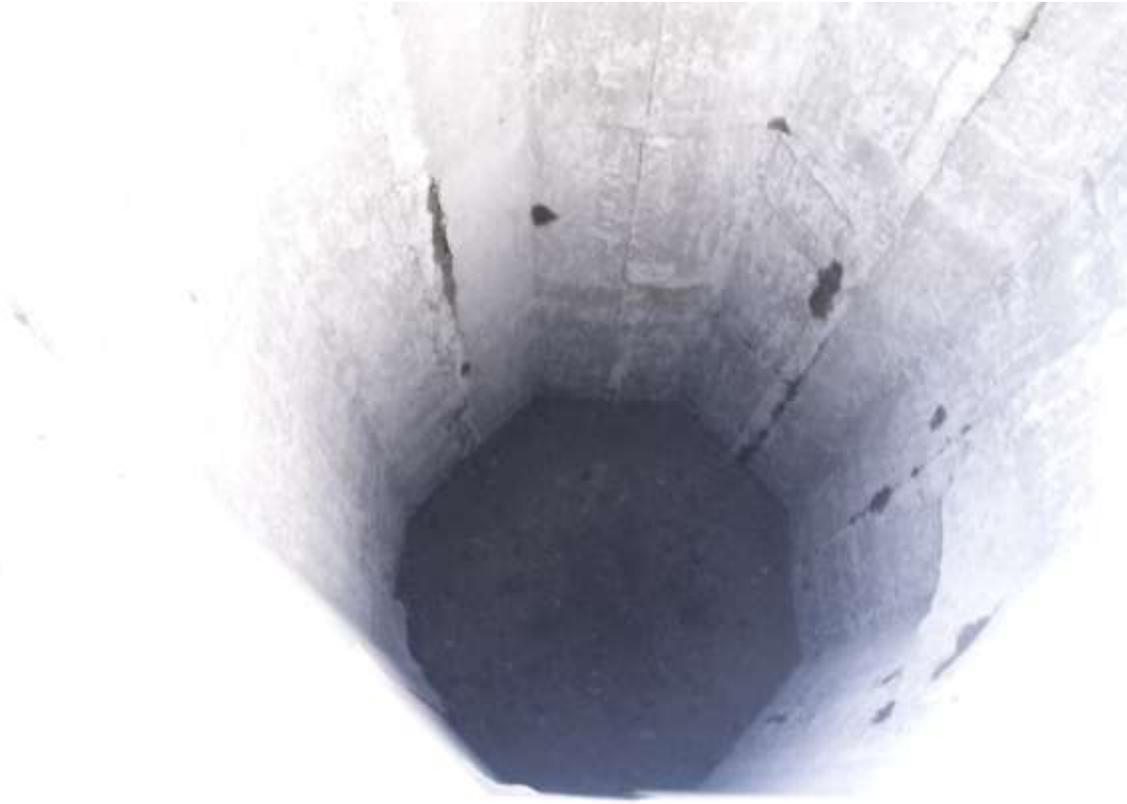
Figure 4. Slurry wall shaft exposed to 100-ft depth.

During panel excavation, panel verticality and continuity was continuously monitored with the Koden. Verticality readings of the same joint obtained from two adjacent previously poured panels were compared for deviation, if any, the panel verticality was corrected. Just prior to placement of concrete, the bentonite slurry was cleaned to achieve a sand content below 5%. The shaft exposed to 100-ft depth is shown in Figure 4.
